Enhanced Preliminary Assessment Report:

Croom Army Housing Units Croom, Maryland

October 1989

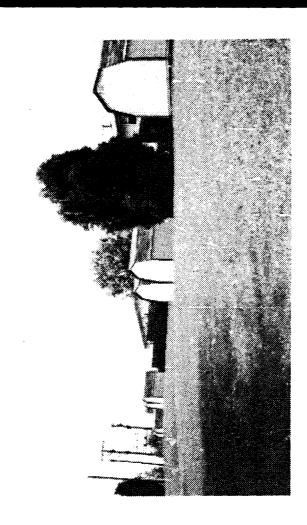
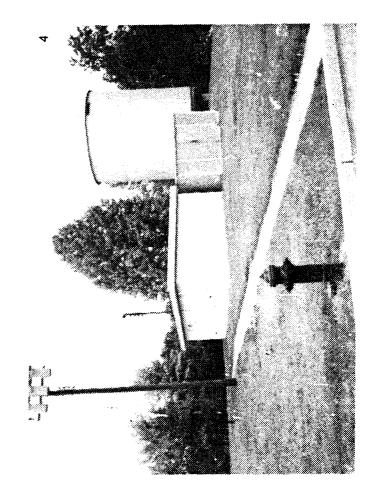
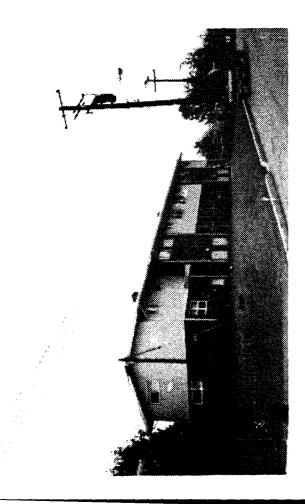
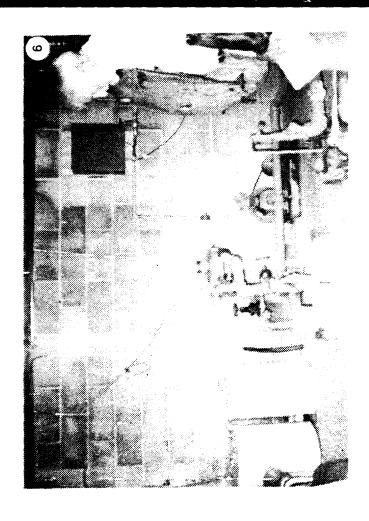
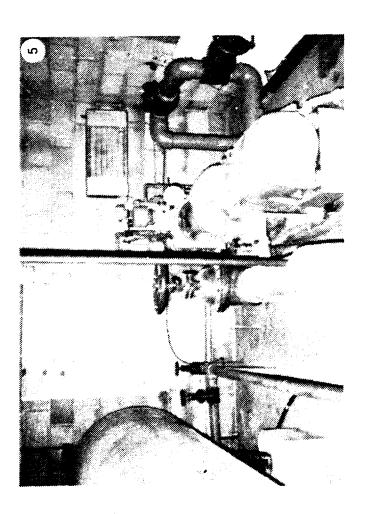
- 1. One of the three apartment buildings; a pole-mounted transformer at top right (transformers maintained by the local utility).
- 2. Storage barns behind the buildings.
- 3. Vent or riser for underground storage tanks. The tanks are located underneath the sidewalk.
- 4. A view (left to right) of the pump house, storage shed, and elevated water storage tank; structures are adjacent to the building on the west side of the street.
- 5. and 6. Inside views of the pump house, showing the motor, plumbing, and other accessories for pumping water from the well.
- 7. The sewage-treatment system; part of the sand-bed filter system (72 feet x 70 feet) is seen in the foreground, with chlorinator house for the treatment of effluent water from the filter bed in the background. Septic tanks, which form part of the treatment system, are underground. The disinfection of wastewater is inadequate.
